Technical Notice

TROUBLE CODE FOR THE EVAPORATIVE SYSTEM

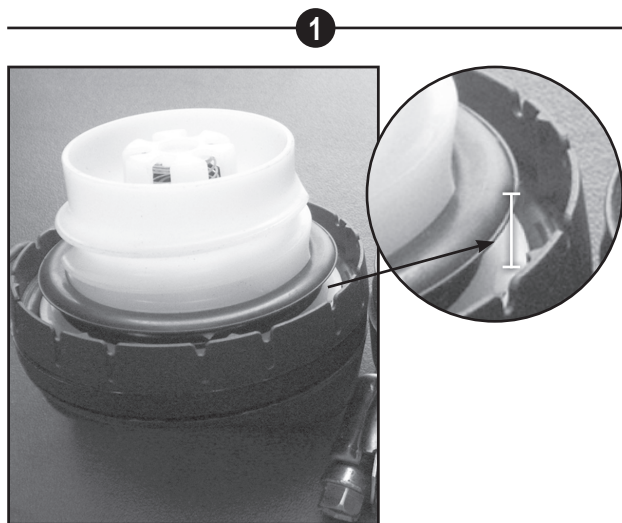
If a diagnostic trouble code for the evaporative system appears after replacing the filler neck, it is important to verify the condition of the filler cap rubber seal.

- ① Good condition rubber seal.
- ② Bad condition rubber seal.

Replace filler cap if necessary.
