## Technical Notice

### TROUBLE CODE FOR THE EVAPORATIVE SYSTEM

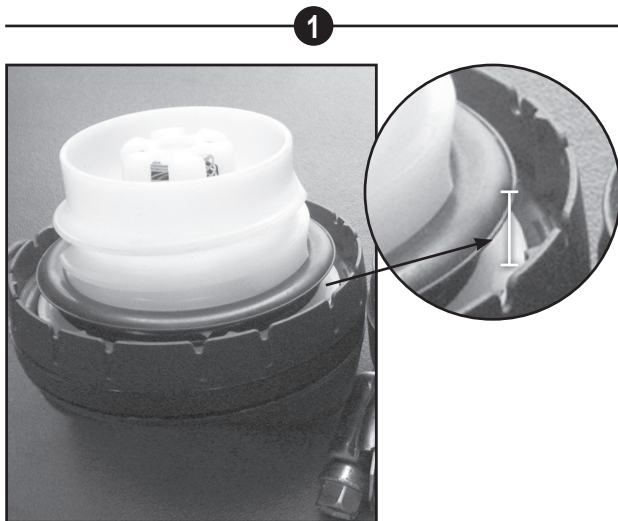
If a diagnostic trouble code for the evaporative system appears after replacing the filler neck, it is important to verify the condition of the filler cap rubber seal.

- ① Good condition rubber seal.
- ② Bad condition rubber seal.

**Replace filler cap if necessary.**
