3" Side Bar

Part No.1110122881/3

Fits: 1988-1998 Chevrolet/GMC C/K Pick Up Extended Cab (2-door cab only)

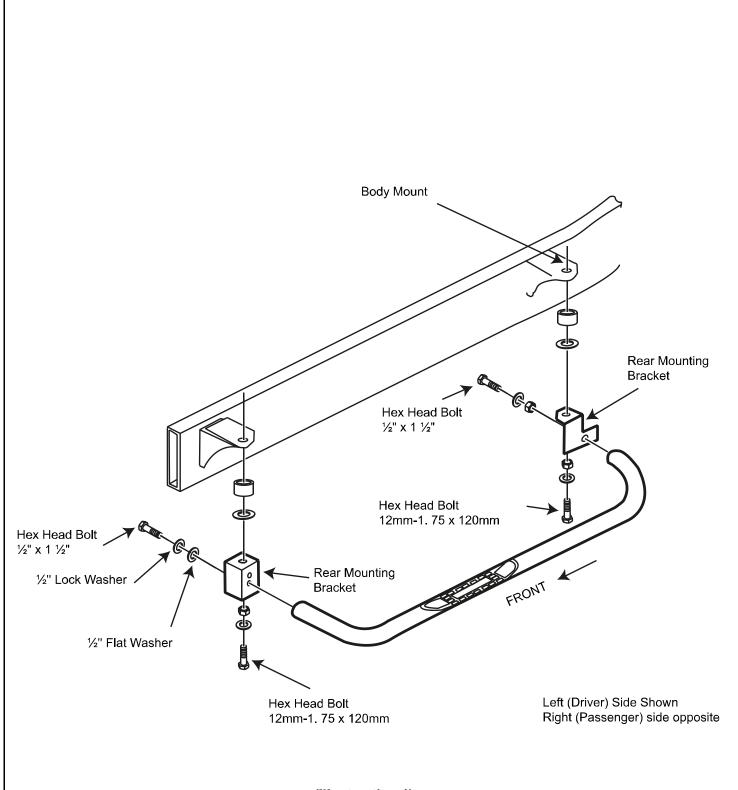
(Illustaration 1)

- Remove the end caps on the side bars before beginning installation.
- Locate the correct Side Bar and set of Brackets referenced in the illustration. (See Illustration1).
- Bracket Installation: Locate the existing bolts on the correct body mounts of the chassis. Remove them and install the brackets. Use the M12 x 1.75 x 120mm Hex Head Bolts with the Flat and Lock Washers. Do not tighten. (See Illustration1).
- Side Bar Installation: Hold the side bar up to the brackets and install using the 1/2" x 1 1/2" Hex Head Bolts with the Flat and Lock Washers. (See Illustration1).
- Tighten the body mount bolts. Then align the Side Bar and tighten the Side Bar bolts.
- Recheck bolts periodically.

DRIVER (LEFT) FRONT	DRIVER (LEFT) REAR	PASSENGER (RIGHT) REAR	PASSENGER (RIGHT) FRONT

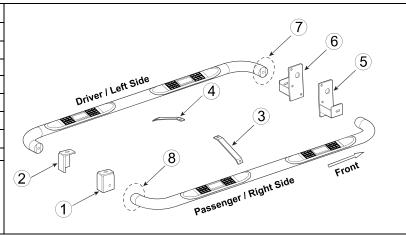
PARTS IDENTIFICATION GUIDE

Driver Side tube taped in "Red" Color. Passenger Side tube taped in "Blue" Color.

No.	Parts Identification	
1	Passenger / Right 'Rear' Bracket marked "RR"	
2	Driver / Left 'Rear' Bracket marked "RL"	
3	Passenger / Right 'Center' Bracket marked "CR"	
4	Driver / Left 'Center' Bracket marked "CL"	
5	Passenger / Right 'Front' Bracket marked "FR"	
6	Driver / Left 'Front' Bracket marked "FL"	
7	'Left' marked "L"	
8	'Right' marked "R"

In some cases Illustration images shown in Installation manual may not be the exactly same as per actual vehicle images ,also if Driver / Passenger side mounting brackets are very identical in the design, suggest referring Parts Identification guide to avoid fitment issue.

Side bar may be interchanged or mounting brackets are not installed at the correct position in the vehicle. Refer Parts identification guide.
