3" Side Bar

Part No. 1120240041/3

Fits: 2004 - 2010

Dodge Durango

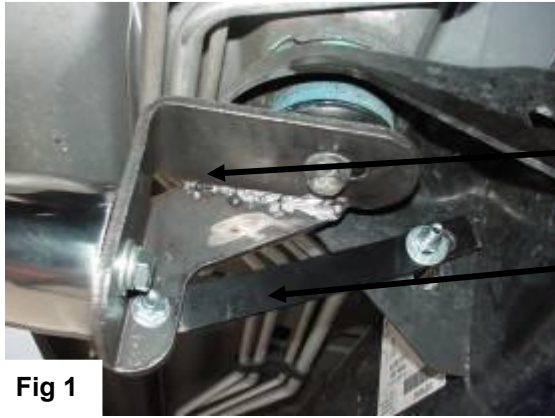
Fig 1

Passengers Side Front Mounting Bracket (looking towards the rear of the vehicle)

Passenger's side auxiliary bracket

1. Remove the end caps on the side bars before beginning installation.
2. Locate the correct Side Bar and set of Brackets referenced to the illustration. (See Fig 1).

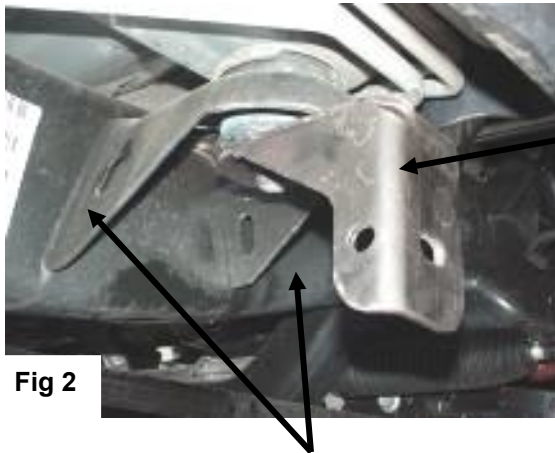
Fig 2

Passenger's Side Front Mounting Bracket (looking towards the front of the vehicle)

Auxiliary bracket bolt up to these holes

3. Locate the existing bolts on the correct body mounts of the chassis. Remove them and install the main brackets (See Fig 2). Use the existing factory bolts. Do not tighten.

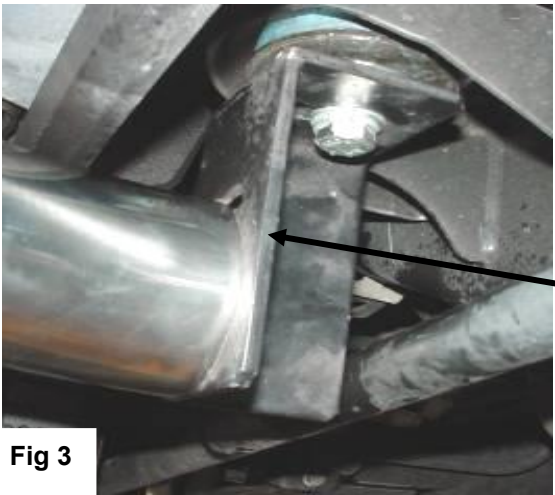
Fig 3

Passenger's side rear bracket

5. Hold the side bar up to the main brackets and install using the 1/2" x 1 1/2" Hex Head Bolts with the Flat and Lock Washers. (See Fig 3, 4)
6. Tighten the body mount bolts. Then align the Side Bar and tighten the Side Bar bolts and auxiliary bracket bolts. Torque body mount bolts to 55 ft. lbs. and torque the remaining 1/2" fasteners to 60 ft. lbs.

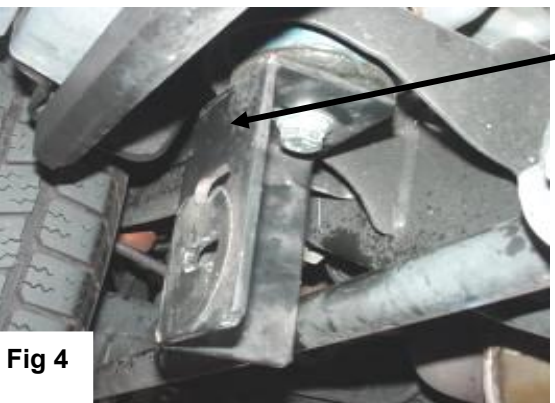
Fig 4

Passenger's side rear bracket (w/out tube mounted)

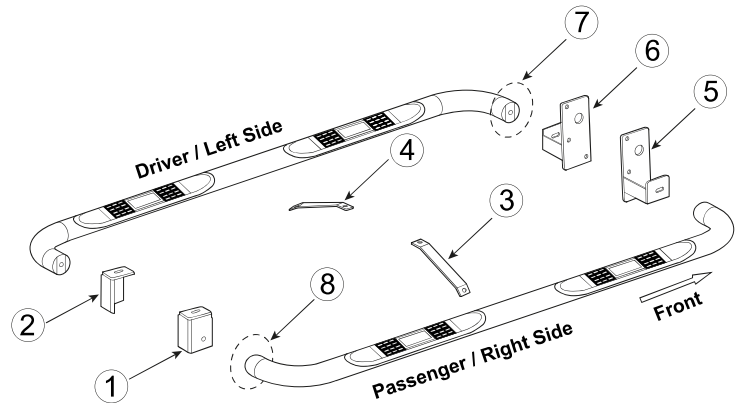
PARTS IDENTIFICATION GUIDE

Driver Side tube taped in "Red" Color. Passenger Side tube taped in "Blue" Color.

No.	Parts Identification
1	Passenger / Right 'Rear' Bracket marked "RR"
2	Driver / Left 'Rear' Bracket marked "RL"
3	Passenger / Right 'Center' Bracket marked "CR"
4	Driver / Left 'Center' Bracket marked "CL"
5	Passenger / Right 'Front' Bracket marked "FR"
6	Driver / Left 'Front' Bracket marked "FL"
7	'Left' marked "L"
8	'Right' marked "R"

In some cases Illustration images shown in Installation manual may not be the exactly same as per actual vehicle images ,also if Driver / Passenger side mounting brackets are very identical in the design, suggest referring Parts Identification guide to avoid fitment issue.

Side bar may be interchanged or mounting brackets are not installed at the correct position in the vehicle. Refer Parts identification guide.
