3" Side Bar

Part No. 1120240981/3

Fits: 1998-2003

Dodge Durango

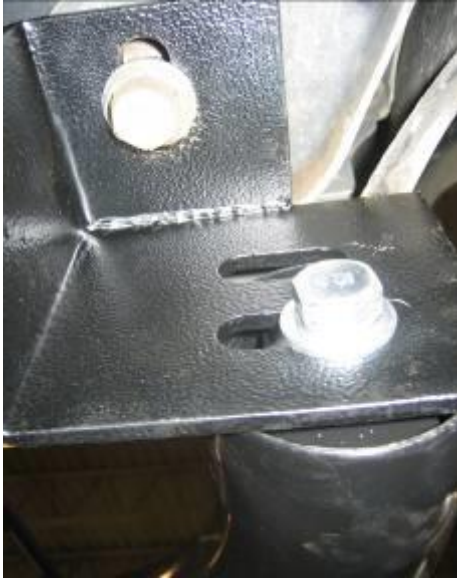
Passenger Side Rear Mounting Bracket

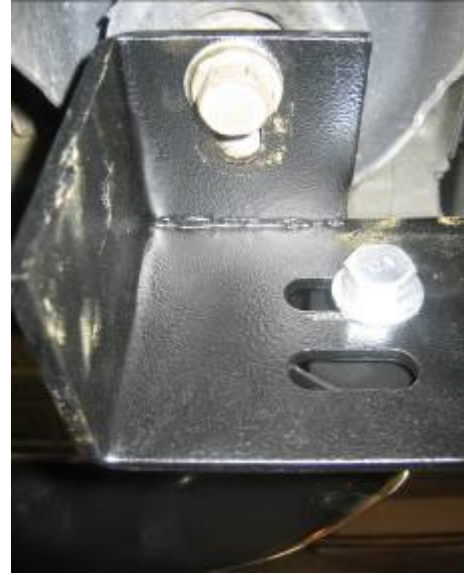
Driver Side Front Mounting Bracket

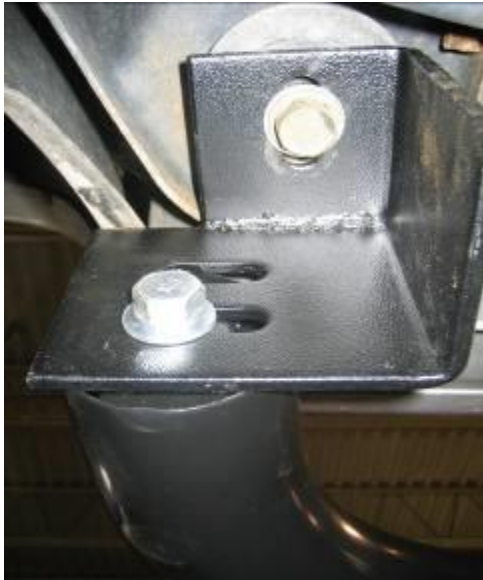
Driver Side Rear Mounting Bracket

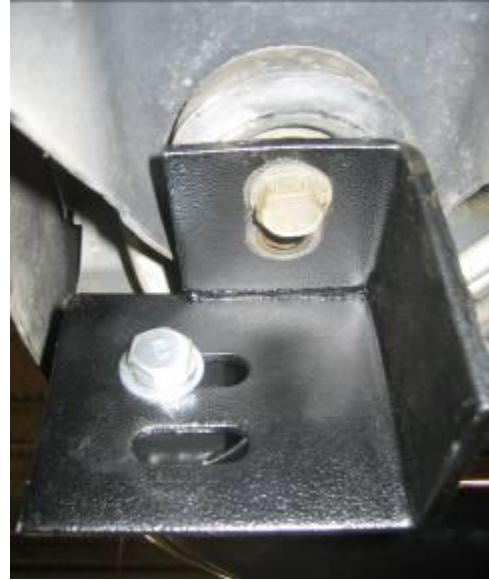
Passenger Side Front Mounting Bracket
