# **Extreme Grille Guard**

Part No. 2720229103

Fits: Fits: 2010-Current Dodge Ram 2500/3500

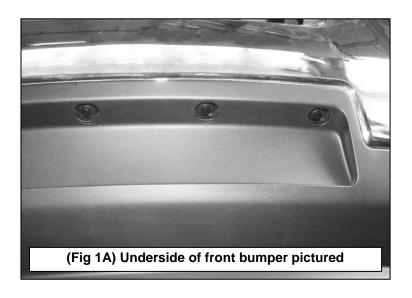
Starting under the front bumper, carefully remove the plastic splash guard from the bottom of the bumper. Depending on the model of truck, the splash guard may be attached to the bumper with hex bolts and several two-piece plastic push-in clips. First, remove all hex bolts, then locate the clips behind and across the front of the bumper, (Figure 1A). Pry up on the center pin of the clip with a flat blade screwdriver to release the pin then remove the entire clip, (Figure 1B). NOTE: Pay close attention to the type and location of all factory hardware for reinstallation. Move the splash guard to a clean stable work area.

Pictured for example only, actual clip may differ

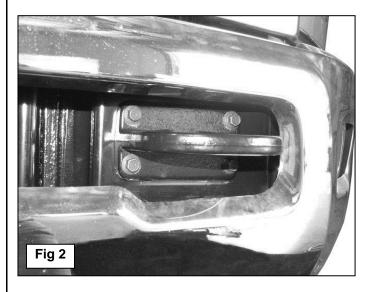
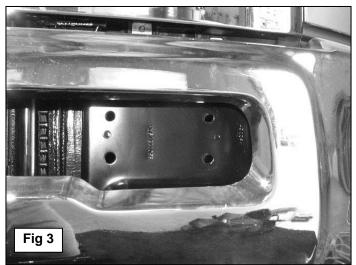
2. Remove the driver side tow hook, (Figure 2). NOTE: The factory hex bolts and nuts securing the inner (2) tow hook bolts may be difficult to remove. Assistance is recommended. Use a socket with a long extension to reach the hex nuts on the inner tow hook bolts. Once the tow hook has been removed, (Figure 3), select the driver side Frame Bracket and place it between the tow hook and the frame. Secure the tow hook and Frame Bracket to the vehicle with (4) 10mm x 45mm Hex Bolts, (8) 10mm Flat Washers, (4) 10mm Lock Washers and (4) 10mm Hex Nuts, (Figure 4). Snug but do not tighten hardware at this time.

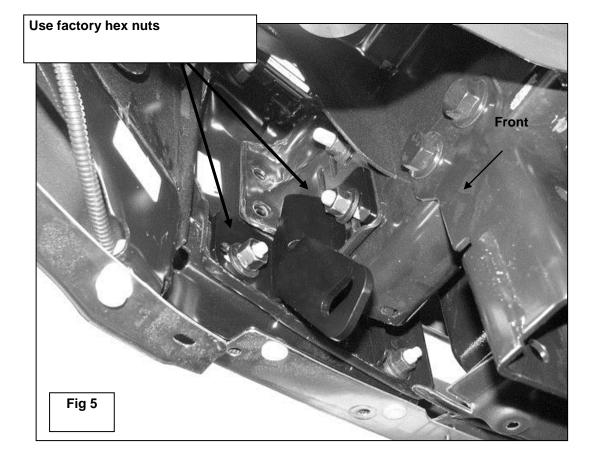
3. Select the driver side Lower Mounting Bracket. Remove the (2) factory hex nuts securing the lower part of the bumper to the bumper bracket. Line up the mounting hole and slot in the Bracket with the (2) bumper bolts and secure with the factory hex nuts, (**Figure 5**). Snug but do not tighten hardware at this time. Repeat Step 3 – 4 for passenger side Mounting Bracket installation.

IMPORANT: To prevent damage to the bumper and/or Frame Mounting Brackets, do not allow the Brackets to come in contact, top or bottom, with the steel bumper

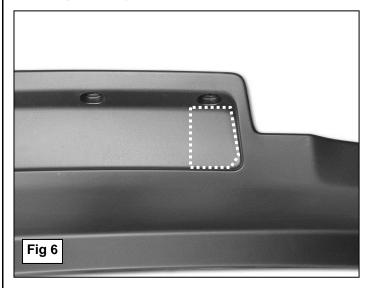
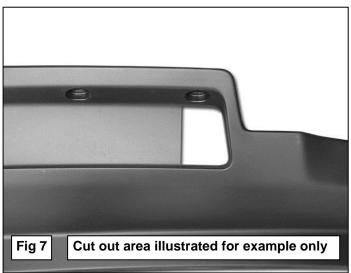
**4.** Hold the plastic splash guard up in the approximate position. Mark the areas indicated onto the driver and passenger side of the splashguard, **(Figure 6)**. Cut out (2) openings for the lower Mounting Brackets, **(Figure 7)**. Reinstall the splash guard using the factory hardware.

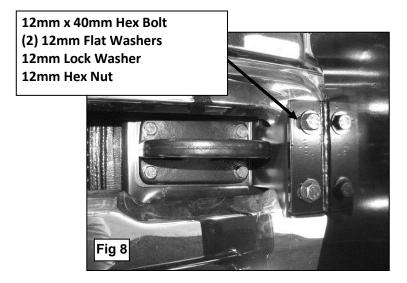
5. With assistance, position the Grille Guard up to the Frame Mounting Brackets. Use the included (4) 12mm x 40mm Hex Bolts, (8) 12mm Flat Washer, (4) 12mm Lock Washers and (4) 12mm Hex Nuts to attach the Grille Guard to the Frame Mounting Brackets, (Figure 8). Insert the lower tabs on the Grille Guard through the openings cut into the splash guard in Step 5. Trim plastic as necessary to properly clear brackets. Snug but do not tighten hardware at this time.

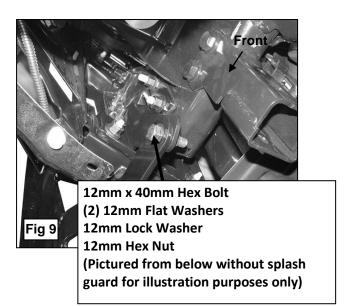
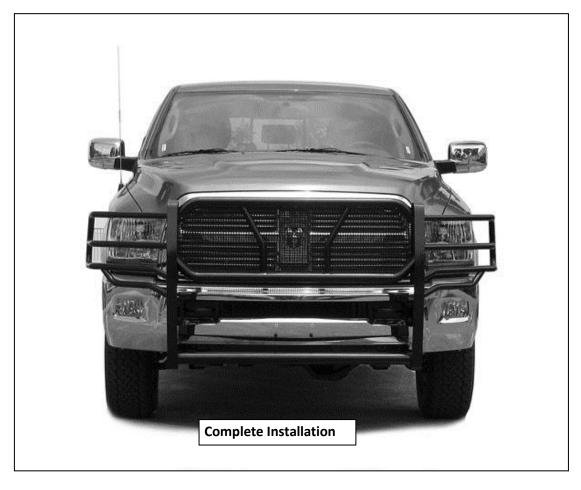
- 6. Line up the holes and attach the Grille Guard to the Lower Mounting Brackets using the included (2) 12mm x 40mm Hex Bolts, (4) 12mm Flat Washers, (2) 12mm Lock Washers and (2) 12mm Hex Nuts, (Figure 9). Snug but do not tighten at this time.
- 7. With assistance, align and adjust the Grille Guard and tighten all hardware. **IMPORTANT:** Do not allow the Frame Mounting Brackets to contact the bumper. Align the Frame Mounting Brackets so that they are centered, side-to-side and that there is an even gap between the Brackets and the steel bumper.
- 8. Do periodic inspections to the installation to make sure that all hardware is secure and tight.
