3" Side Bar

Part No. A0005S/B

Fits: 2005-Current Nissan Frontier Crew Cab

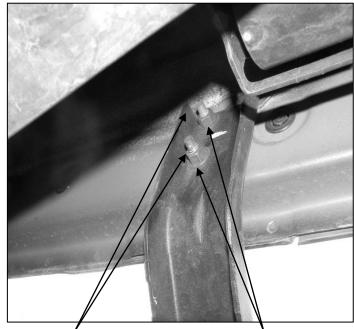
FIG. #1PASSENGER SIDE SHOWN

- On the passenger/right side, if equipped, remove the existing running board by removing the four nuts holding mount to
 inside of body. Install the two passenger/right side mounting brackets with the removed stock nuts, leave nuts loose for
 now. NOTE: Holes in brackets are off set, install with holes towards front of truck, passenger/right side shown. See Fig. #1

EXISTING NUTS NOTE: If vehicle is not equipped with factory Sidebars use the included 8mm Hex Nuts 8mm Lock Washers 8mm Flat Washers

OFF CENTER HOLES

- 2. If not equipped with factory running boards then use the four supplied 8mm nuts, washers & lock washers to install mounting brackets to truck.
- 3. Repeat procedures 1 & 2 for driver/left side.

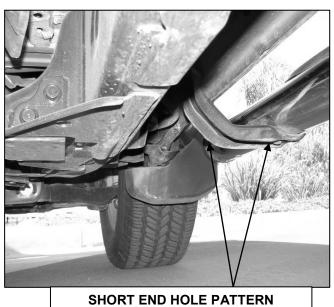
FIG. #2 PASSENGER SIDE SHOWN

- **4.** Install side bar onto mounting brackets using four 8X30mm hex head bolts, four 8mm lock washers & four 8mm flat washers. Leave bolts loose short end whole pattern installs towards the front of truck, passenger/right side shown.

- 5. Repeat procedure #4 on driver/left side.
- **6.** Level and adjust side bars as desired and tighten.
- 7. Do periodic inspections to the installation to make sure that all hardware is secure and tight.
