# 3" Side Bar

## Part No. A0006S/B

Fits: 2005-Current Nissan Frontier King Cab

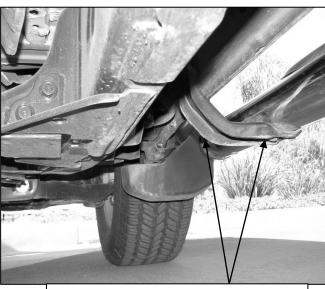
## FIG. #2 PASSENGER SIDE SHOWN

SHORT END HOLE PATTERN

OFF CENTER HOLES

- **4.** Install side bar onto mounting brackets using four 8X30mm hex head bolts, four 8mm lock washers & four 8mm flat washers. Leave bolts loose short end whole pattern installs towards the front of truck, passenger/right side shown.
