3" Side Bar

Part No. A0009S/B

Fits: 2005 - Current Toyota Tacoma Access Cab

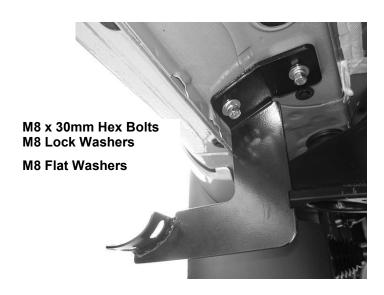
(Fig 1) Driver side front mounting location

- 1. Starting on the driver side front of the vehicle, use a flat screw driver to remove the plastic plugs, (Figure 1). Partially attach drivers side front Mounting Bracket to vehicle using the included (2) 8mm x 30mm Hex Bolts, (2) 8mm Lock Washers and (2) 8mm Flat Washers, (Figure 2). Repeat this step for installing the driver's side rear Mounting Bracket, (Figure 3)
- 2. Align the threaded inserts on the Side Bar with the slots on the Mounting Brackets. Attach Sidebar to Mounting Brackets with the included (4) 8mm x 30mm Hex Bolts, (4) 8mm Flat Washers and (4) 8mm Lock Washers, (Figure 3). Do not tighten hardware at this time.
- 3. Level and adjust the Sidebar properly and tighten all hardware.
- 4. Repeat Steps 2-4 for installing passenger Sidebar.

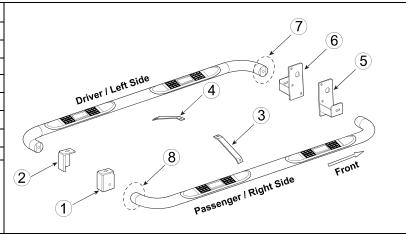
PARTS IDENTIFICATION GUIDE

Driver Side tube taped in "Red" Color. Passenger Side tube taped in "Blue" Color.

No.	Parts Identification		
1	Passenger / Right 'Rear' Bracket marked "RR"		
2	Driver / Left 'Rear' Bracket marked "RL"		
3	Passenger / Right 'Center' Bracket marked "CR"		
4	Driver / Left 'Center' Bracket marked "CL"		
5	Passenger / Right 'Front' Bracket marked "FR"		
6	Driver / Left 'Front' Bracket marked "FL"		
7	'Left' marked "L"		
8	'Right' marked "R"

In some cases Illustration images shown in Installation manual may not be the exactly same as per actual vehicle images ,also if Driver / Passenger side mounting brackets are very identical in the design, suggest referring Parts Identification guide to avoid fitment issue.

Side bar may be interchanged or mounting brackets are not installed at the correct position in the vehicle. Refer Parts identification guide.
