4" Oval Straight Side Bar

Part No. A1542S/B

Dodge Ram 1500 Crew Cab

Fits: 2019

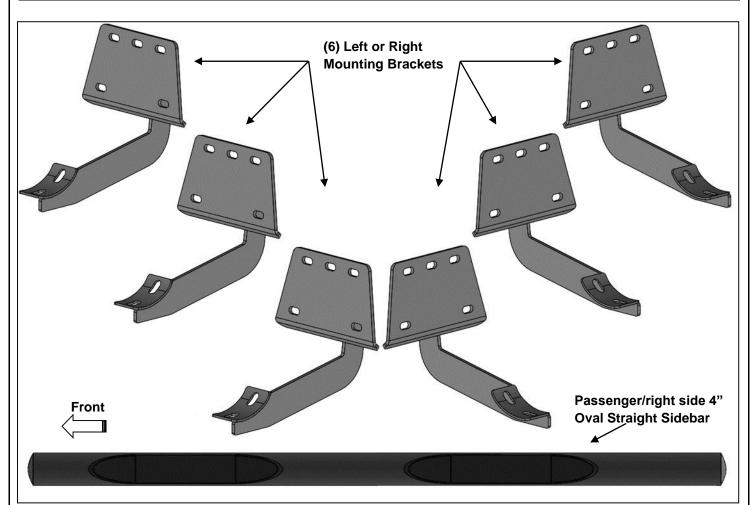
PARTS LIST:				
Qty	Part Description	Qty	Part Description	
1	Driver/left side 4" Oval Straight Sidebar	12	8-1.25mm x 25mm Combo Hex Bolts	
1	Passenger/right side 4" Oval Straight Sidebar	18	8mm x 24mm x 2mm Flat Washers	
6	Mounting Brackets	18	8-1.25mm Nylon Lock Nuts

- Repeat Steps 1 & 2 to install the Universal Brackets in the center and rear mounting locations along the body panel, (Figures 3 & 4).
- 4. Carefully unwrap and select the Passenger/right Sidebar. Use the illustration above to help identify the correct Sidebar. Place the Sidebar on top of the Brackets. **IMPORTANT**: Do not slide, (front to back or rotate), the Sidebar on the Brackets or damage to the finish on the Sidebar may result.

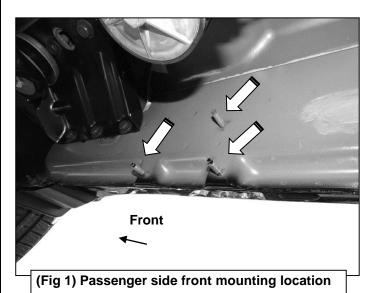
- 1. Start the installation under the passenger side of the vehicle. Locate the front (3) factory studs along the inner side of the body panel, (Figure 1). NOTE: Chase threads on the studs first before installing Brackets to remove paint buildup.

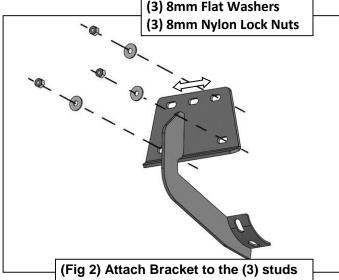
- 2. Select (1) Mounting Bracket. NOTE: All (6) Brackets are universal and will fit left or right side. Attach the Mounting Bracket to the (3) factory studs with (3) 8mm Flat Washers and (3) 8mm Nylon Lock Nuts, (Figure 2). Leave brackets loose at this time.

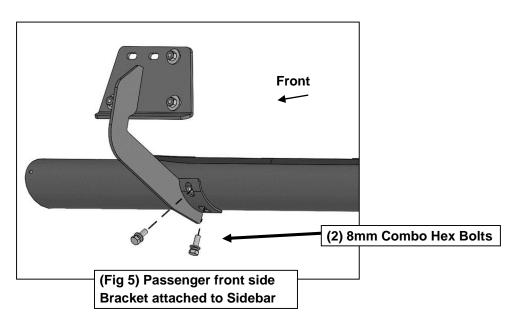
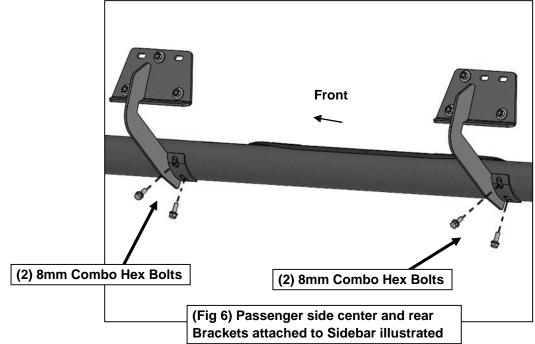
- 5. Attach the Sidebar to the Brackets with (6) 8mm Combo Hex Bolts, (Figures 5 & 6). Do not tighten hardware at this time.
- 6. Level and adjust the Sidebar as necessary and fully tighten all hardware.
