Fits: 2007-Current

5" Oval Straight Side Bar

Part No. A7011S/B

Toyota Tundra Crew Max

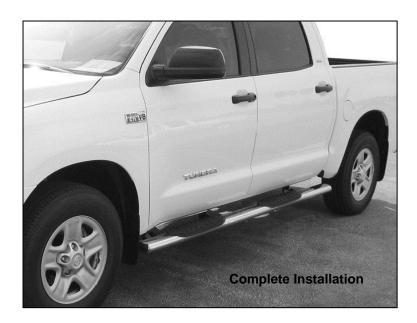
- 3. Carefully place the Driver/Left Sidebar onto the (3) Brackets. Align the threaded holes in the bottom of the Sidebar with the holes on the Mounting Brackets. Attach the Sidebar to the Mounting Brackets with the included (6) 8mm x 30mm Hex Bolts, (6) 8mm Lock Washers and (6) 8mm Flat Washers, (Figures 3 5). Do not tighten at this time.
- 4. Level and adjust the Sidebar properly and tighten all hardware.
- **5.** Repeat Steps 1-4 for passenger Sidebar installation.
- **6.** Do periodic inspections to the installation to make sure that all hardware is secure and tight.
