5" Oval Bend End Bar

Part No. A7081S /B

Dodge Ram 1500 Crew Cab

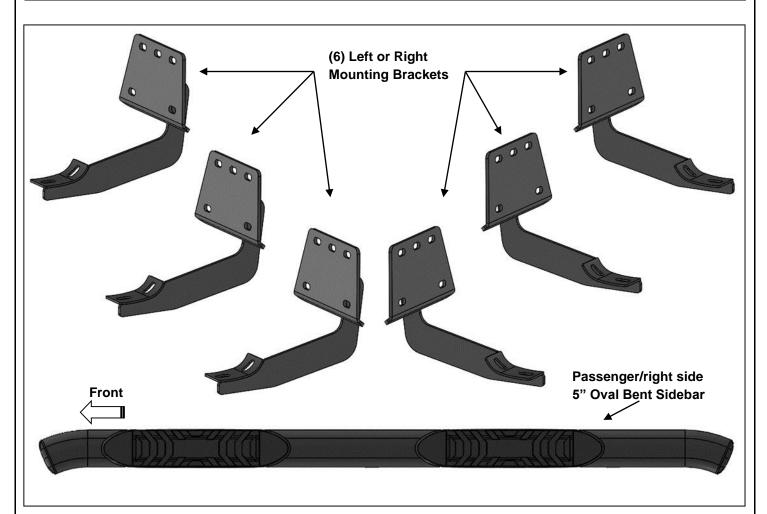
PARTS LIST:				
Qty	Part Description	Qty	Part Description	
1	Driver/left side 5" Oval Bent End Sidebar	12	8-1.25mm x 25mm Combo Hex Bolts	
1	Passenger/right side 5" Oval Bent End Sidebar	18	8mm x 24mm x 2mm Flat Washers	
6	Mounting Brackets	18	8-1.25mm Nylon Lock Nuts

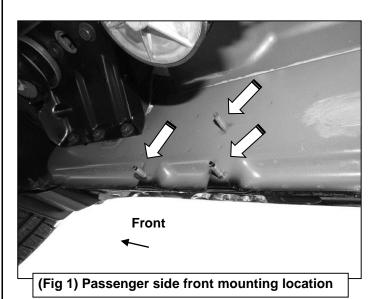
- 1. Start the installation under the passenger side of the vehicle. Locate the front (3) factory studs along the inner side of the body panel, (Figure 1).

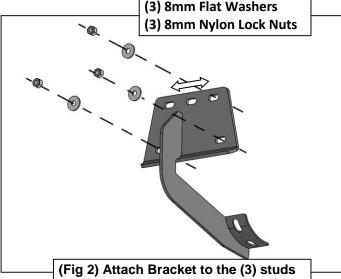
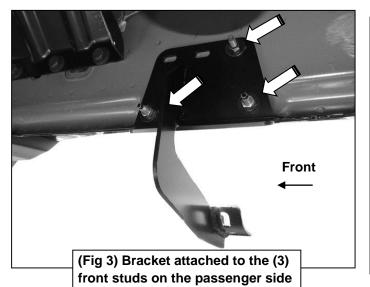
- 2. Select (1) Mounting Bracket. **NOTE**: All (6) Brackets are universal and will fit left or right side. Attach the Mounting Bracket to the (3) factory studs with (3) 8mm Flat Washers and (3) 8mm Nylon Lock Nuts, **(Figures 2 & 3)**. Leave brackets loose at this time.

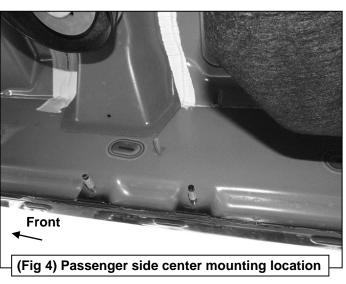
- 3. Repeat **Steps 1 & 2** to install the Universal Brackets in the center and rear mounting locations along the body panel, **(Figure 4—7)**.
- 4. Carefully unwrap and select the Passenger/right Sidebar. Use the illustration above to help identify the correct Sidebar. Place the Sidebar on top of the Brackets. **IMPORTANT**: Do not slide, (front to back or rotate), the Sidebar on the Brackets or damage to the finish on the Sidebar may result.
