# 5" Oval Bend End Bar

# Part No. A7082S/B

# Dodge Ram 1500 Crew Cab

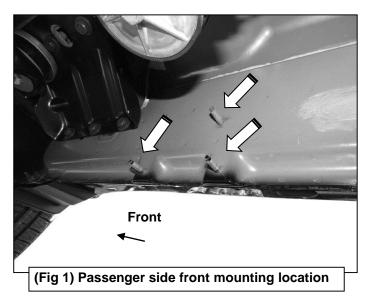
- 1. Start the installation under the passenger side of the vehicle. Locate the front (3) factory studs along the inner side of the body panel, (Figure 1).

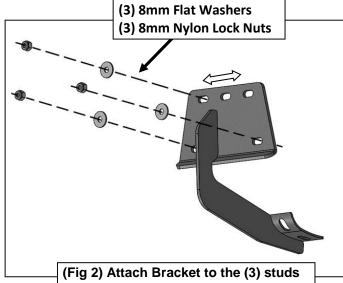
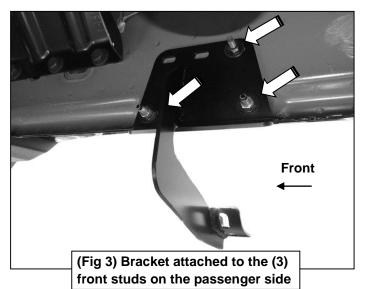
- Select (1) Mounting Bracket. NOTE: All (6) Brackets are universal and will fit left or right side. Attach the Mounting Bracket to the (3) factory studs with (3) 8mm Flat Washers and (3) 8mm Nylon Lock Nuts, (Figures 2 & 3). Leave brackets loose at this time.

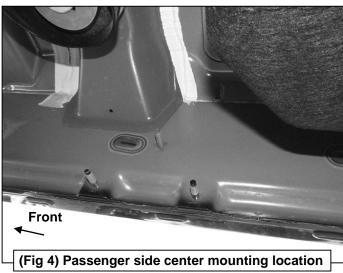
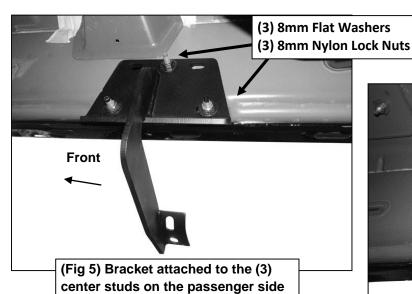
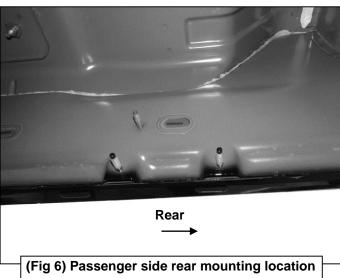
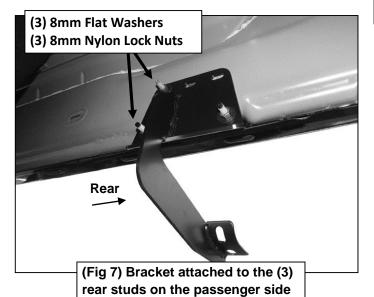
- Repeat Steps 1 & 2 to install the Universal Brackets in the center and rear mounting locations along the body panel, (Figure 4—7).
- 4. Carefully unwrap and select the Passenger/right Sidebar. Use the illustration above to help identify the correct Sidebar. Place the Sidebar on top of the Brackets. **IMPORTANT**: Do not slide, (front to back or rotate), the Sidebar on the Brackets or damage to the finish on the Sidebar may result.

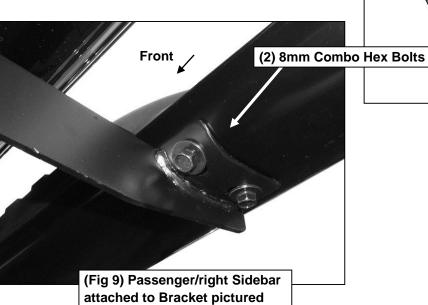
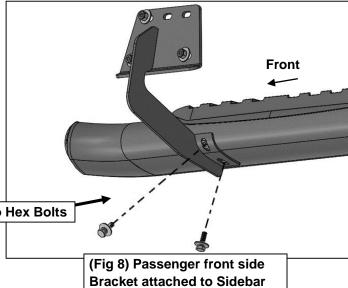
- 5. Attach the Sidebar to the Brackets with (6) 8mm Combo Hex Bolts, (Figures 8 & 9). Do not tighten hardware at this time.
- 6. Level and adjust the Sidebar as necessary and fully tighten all hardware.
