6" Oval Nerf Bar

Part No. A8215S/B

Fits: 2005 - Current

Toyota Tacoma Double Cab

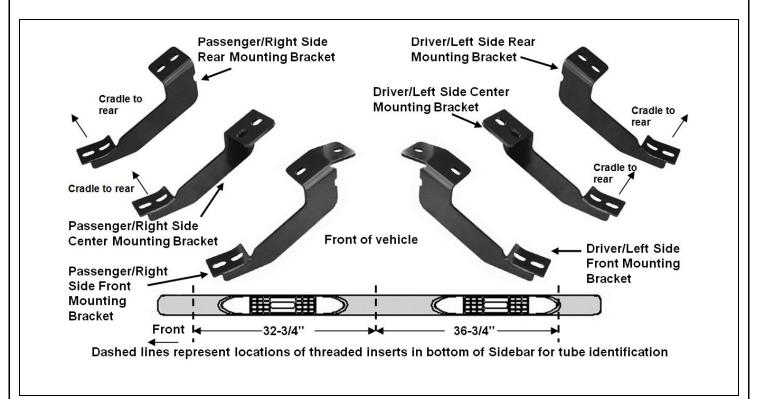
PARTS LIST:				
Qty	Part Description	Qty	Part Description	
1	Driver Sidebar	1	Driver/Left Rear Mounting Bracket	
1	Passenger Sidebar	1	Passenger/Right Rear Mounting Bracket	
1	Driver/Left Front Mounting Bracket	24	8-1.25mm x 30mm Hex Bolts	
1	Passenger/Right Front Mounting Bracket	24	8mm x 24mm OD x 2mm Flat Washers	
1	Driver/Left Middle Mounting Bracket	24	8mm Lock Washers	
1	Passenger/Right Middle Mounting Bracket

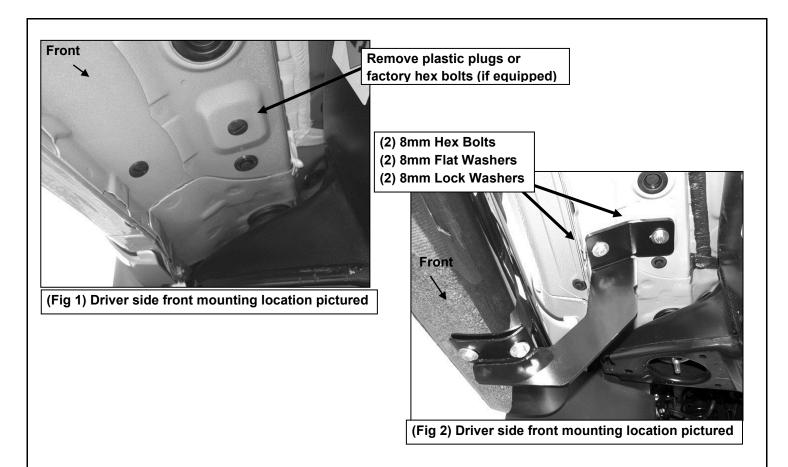
1. Starting on the driver side front of the vehicle, use a flat screw driver to remove the plastic plugs covering the threaded holes in the body panel, (Figure 1). Select the driver side front Mounting Bracket and bolt it to the vehicle using the included (2) 8mm x 30mm Hex Bolts, (2) 8mm Lock Washers and (2) 8mm Flat Washers, (Figure 2). Do not tighten hardware at this time.

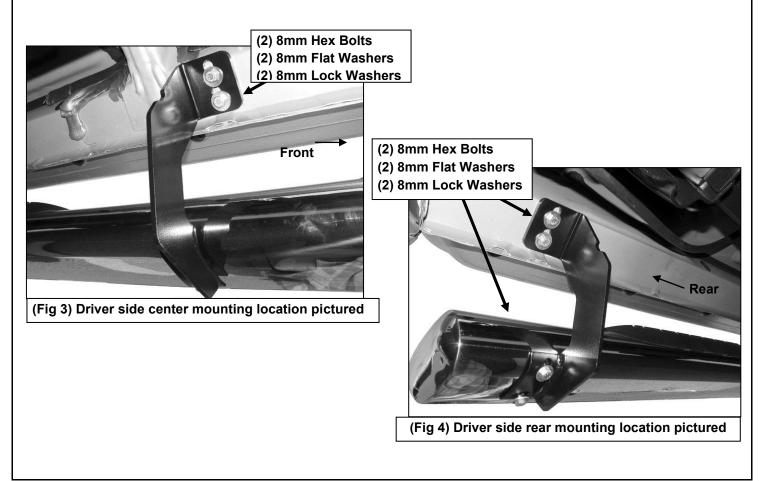
- 2. Repeat Step 1 for center and rear Mounting Bracket installation, (Figures 3 & 4).
- 3. **IMPORTANT**: Use the illustration on this page to identify the sidebars before continuing with the installation. Verify that the Brackets are in the correct locations as illustrated above. Carefully place the driver Sidebar onto the Brackets. Align the inserts in the bottom of the Sidebar with the slots on the Mounting Brackets. Attach the Sidebar to the Mounting Brackets with the included (6) 8mm x 30mm Hex Bolts, (6) 8mm Lock Washers and (6) 8mm Flat Washers, (**Figure 4**). Do not tighten hardware at this time.

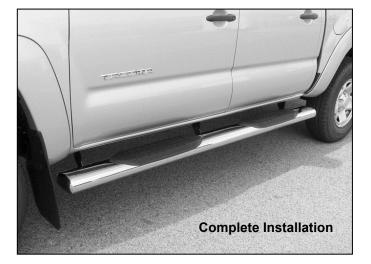
PARTS IDENTIFICATION GUIDE

Driver Side tube packed using "Green" color foam sheet. Passenger Side tube packed using "White" color foam sheet

No.	Parts Identification	(6)
1	Passenger / Right 'Rear' Bracket marked "PR"	
2	Driver / Left 'Rear' Bracket marked "DR"	
3	Passenger / Right 'Center' Bracket marked "PC"	Driver / Left Side
4	Driver / Left 'Center' Bracket marked "DC"	
5	Passenger / Right 'Front' Bracket marked "PF"	
6	Driver / Left 'Front' Bracket marked "DF"	
> F	This guide is to identify the parts and not a reference for part count. For part count, refer Parts List. Product / Bracket image is representative and actual design may vary.	2 1 Passenger Right Side Passenger Right Side

In some cases Illustration images shown in Installation manual may not be the exactly same as per actual vehicle images ,also if Driver / Passenger side mounting brackets are very identical in the design, suggest referring Parts Identification guide to avoid fitment issue.

Side bar may be interchanged or mounting brackets are not installed at the correct position in the vehicle. Refer Parts identification guide.
