6" Oval Straight Side Bar

Part No. A8254S /B

Fits: 2019 DODGE RAM 1500 QUAD CAB

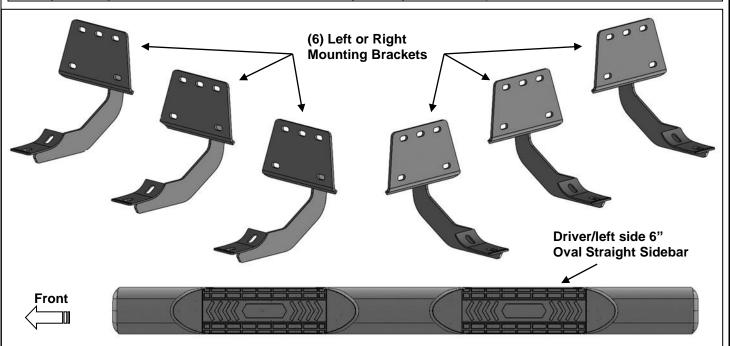
| PARTS LIST: | | | | |
| Qty | Part Description | Qty | Part Description | |
| 1 | Driver/left side 6" Oval Straight Sidebar | 12 | 8-1.25mm x 25mm Combo Hex Bolts | |
| 1 | Passenger/right side 6" Oval Straight Sidebar | 18 | 8mm x 24mm x 2mm Flat Washers | |
| 6 | Mounting Brackets | 18 | 8-1.25mm Nylon Lock Nuts | |

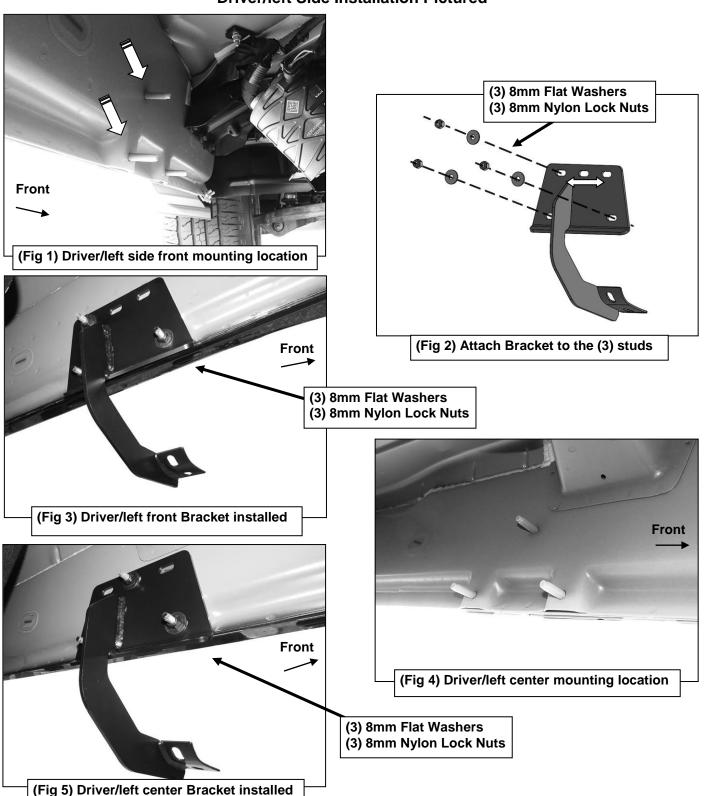
Driver/left Side Installation Pictured

- 1. Start the installation under the driver side of the vehicle. Locate the front (3) factory stude along the inner side of the body panel, (Figure 1). Use a wire brush or thread chaser die to remove excess paint or undercoating from threaded stude as necessary.
- 2. Select (1) Mounting Bracket. **NOTE**: All (6) Brackets are universal and will fit left or right side. Attach the Mounting Bracket to the (3) factory studs with (3) 8mm Flat Washers and (3) 8mm Nylon Lock Nuts, (Figures 2 & 3). Leave brackets loose at this time.

- Repeat Steps 1 & 2 to install the Brackets in the center and rear mounting locations along the body panel, (Figures 4—6).
- 4. Carefully unwrap and select the Driver/left Sidebar. Use the illustration above to help identify the correct Sidebar. Place the Sidebar on top of the Brackets. IMPORTANT: Do not slide, (front to back or rotate), the Sidebar on the Brackets or damage to the finish on the Sidebar may result.
- **5.** Attach the Sidebar to the Brackets with (6) 8mm Combo Hex Bolts, **(Figures 7—10)**. Do not tighten hardware at this time.
- **6.** Level and adjust the Sidebar as necessary and fully tighten all hardware.
- 7. Repeat **Steps 1—6** for Passenger/right Sidebar installation.
- 8. Do periodic inspections to the installation to make sure that all hardware is secure and tight.

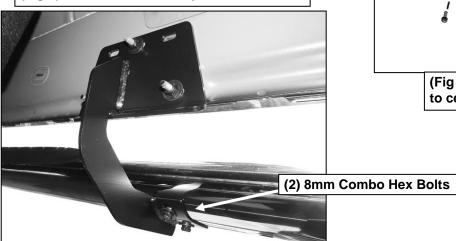
(Fig 8) Driver/left front complete installation

Front

(2) 8mm Combo

Hex Bolts
