# Bed Rail

## Part No. D0001S/B

Fits: 2014 - CURRENT Chevrolet Silverado/GMC Sierra 1500 With 6.5' Standard Bed  
2015 - CURRENT Chevrolet Silverado/GMC Sierra 2500/3500 With 6.5' Standard Bed

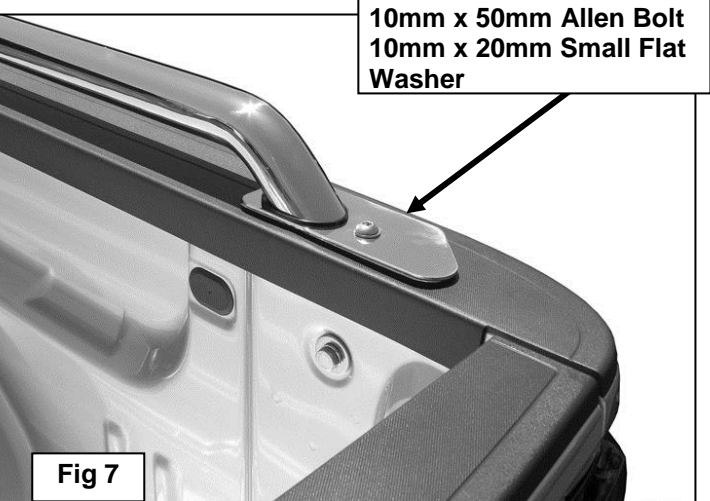
Fig 7

10mm x 50mm Allen Bolt  
10mm x 20mm Small Flat Washer

6. Move to the rear location. Line up the hole in the mounting plate on the Bed Rail with the 10mm Nut Plate Bracket inside the stake pocket, **(see Step 2, Fig. 2B)**. Secure the Bed Rail to the Bracket with (1) 10mm Button Head Allen Bolt with (1) 10mm Small Flat Washer, **(Figure 7)**. Do not tighten hardware at this time.
