Bed Rail

Part No. D0001S/B

Fits: 2014 - CURRENT Chevrolet Silverado/GMC Sierra 1500 With 6.5' Standard Bed
 2015 - CURRENT Chevrolet Silverado/GMC Sierra 2500/3500 With 6.5' Standard Bed

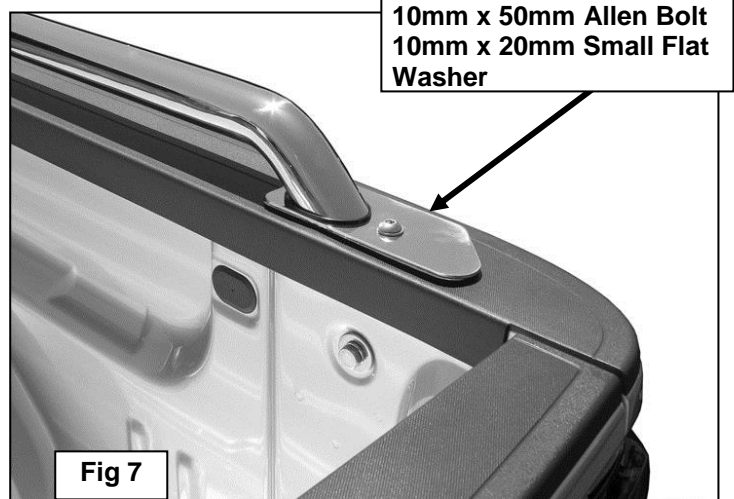
Fig 7

**10mm x 50mm Allen Bolt
10mm x 20mm Small Flat Washer**

6. Move to the rear location. Line up the hole in the mounting plate on the Bed Rail with the 10mm Nut Plate Bracket inside the stake pocket, **(see Step 2, Fig. 2B)**. Secure the Bed Rail to the Bracket with (1) 10mm Button Head Allen Bolt with (1) 10mm Small Flat Washer, **(Figure 7)**. Do not tighten hardware at this time.

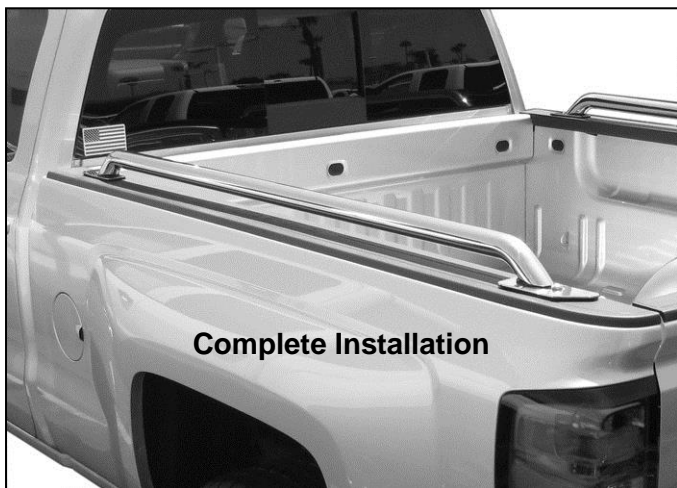
Complete Installation
