# **Rear Bumper**

Part: J033T

Fit: 2007- Current Jeep Wrangler JK

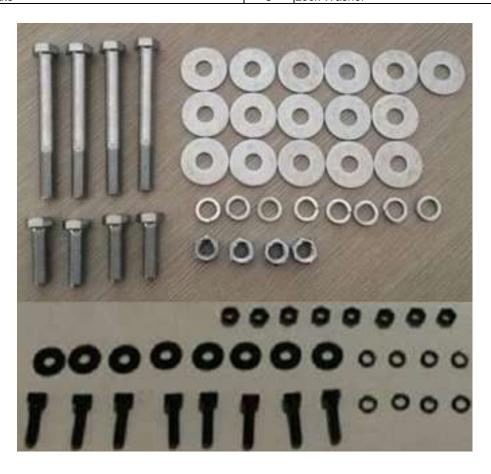
BUMPER INSTALLATION PARTS					
Qty	Part Description	Qty	Part Description		
4	M12x110 mm x30mm Outer Hex Bolts	16	12 mm x 1.5mm Flat Washers		
4	M12x 35 mm Outer Hex Bolts	8	12 mm Lock Washer		
4	M12 Hex Nuts

LIGHT INSTALLATION PARTS					
Qty	Part Description	Qty	Part Description		
8	M6 x 20 mm Inside Hex Bolts	8	M8 Flat Washer		
8	M6 Hex Nuts	8	Lock Washer

- **Step 1:** Remove the factory rear bumper and support brackets from the vehicle.
- **Step 2:** Position the rear bumper up into place, aligning the four holes in the centre of the frame with the holes bumper. Attach using the supplied M12 X 35mm bolts with flat washers and nuts. Do not fully tighten at this time.
- **Step 3:** Install the four M12 x 110mm bolts thought the side brackets on the frame.
- Step 4: Make sure bumper is level and the completely tighten all hardware.
- Step 5: Installation is now complete.
