Running Board

Part No. RBW07B

Fits: 1999 - Current

Ford F250/350/450/550 Super duty Super Cab

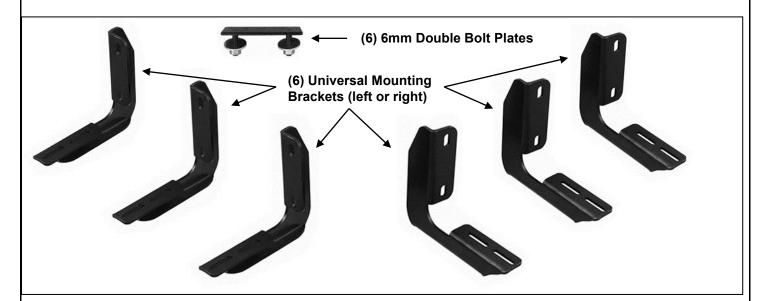
PARTS LIST:				
Qty	Part Description	Qty	Part Description	
2	Steel Running Boards	6	8-1.25mm Nylon Lock Nuts	
6	Universal Mounting Brackets (left of right)	6	6mm Double Bolt Plates	
6	8-1.25mm Clip-Nuts	12	6mm x 22mm OD x 2mm Flat Washers	
12	8-1.25mm x 25mm Hex Bolts	12	6mm Lock Washers	
18	8mm x 24mm x 2mm Flat Washer	12	6mm Hex Nuts	
6	8mm Lock Washers

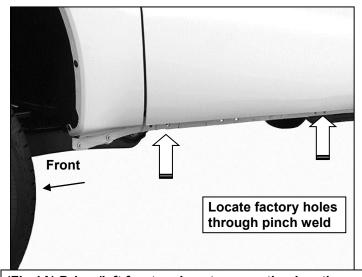
(Fig 1A) Driver/left front and center mounting locations

- Starting on the front-driver side of the vehicle, locate the (2) holes through the bottom of the body panel, (pinch weld-Figure 1A). Next locate the rectangular opening and (2) small holes in the inner body panel directly above the holes in the pinch weld, (Figures 1B & 2). NOTE: The holes in the inner panel may be covered with sealing tape or insulation, remove as required.

- 4. Move to the center mounting location, (Figure 4). NOTE: There are (4) factory mounting locations along the inner body panel. Installation will use the 1st, 3rd and 4th mounting locations only. Refer to Figures 1A & 1B to help identify the correct locations. Repeat Steps 2—4 to install the center Bracket in the rear set of mounting holes, (Figure 5).

- Move toward the rear of the cab. Locate the last pair of holes along the pinch weld. Use Figure 1B to determine the correct mounting location for the rear Bracket. Repeat Steps 2—4 to install (1) Mounting Bracket in the rear pair of holes in the rear location, (Figure 9).

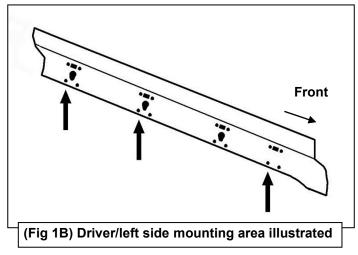
- 2. Slide (1) 8mm Clip Nut into the rectangular opening with the nut towards the inside. Line up the threaded nut on the clip with the round hole toward the rear, (Figure 2).

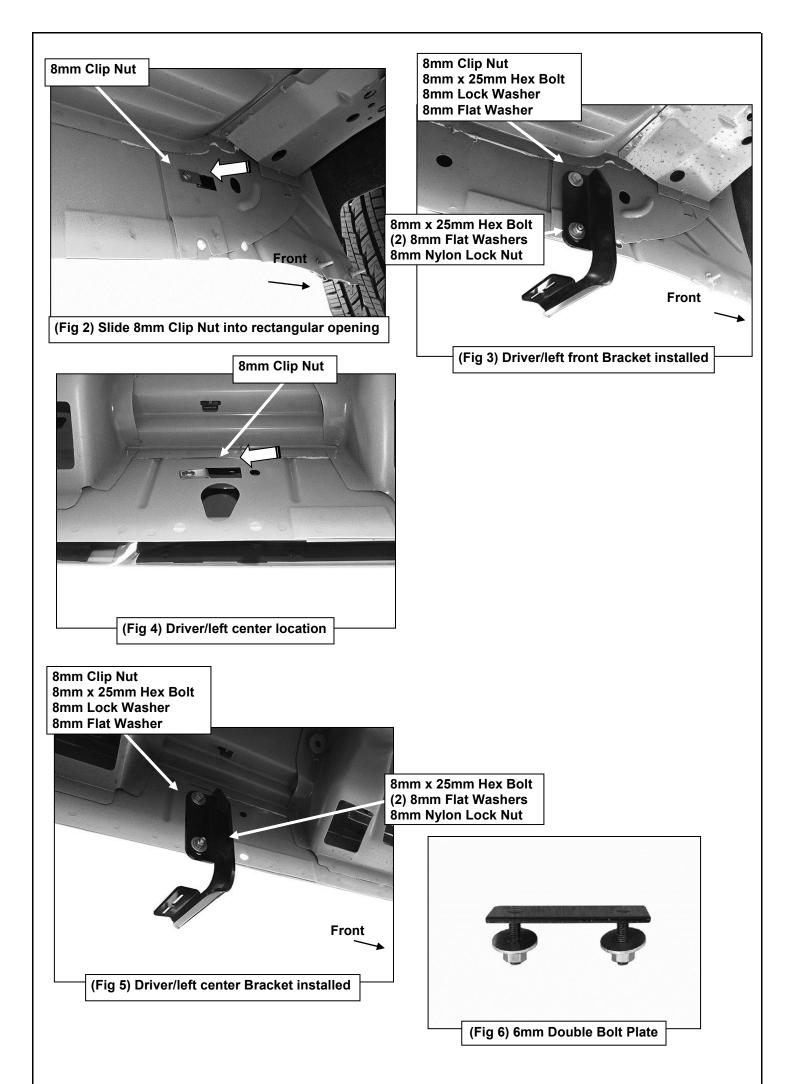
- 3. Select (1) Mounting Bracket. Attach the top of the Bracket to the Clip Nut with (1) 8mm x 25mm Hex Bolt, (1) 8mm Lock Washer and (1) 8mm Flat Washer, (Figure 3). Leave loose at this time. Line up the lower hole in the Bracket with the hole through the pinch weld. Bolt the Bracket to the pinch weld with (1) 8mm x 25mm Hex Bolt, (2) 8mm Flat Washers and (1) 8mm Nylon Lock Nut, (Figures 3 & 8). Snug but do not fully tighten Bracket hardware.

- 6. Once the (3) Brackets have been fully installed, select (1) Running Board. Place the Running Board on top of the Brackets. Locate the channels in the bottom of the Running Board. Select (3) 6mm Double Bolt Plates, (Figure 6). Insert the Bolt Plates into the channels in the bottom of the Running Board closest to the Brackets, (Figure 7). Lift the Board up and guide the studs through the Brackets.

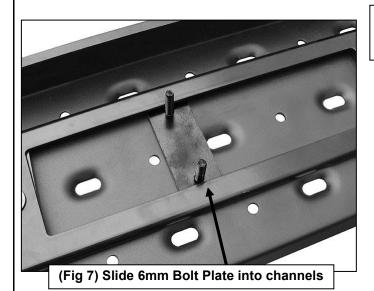
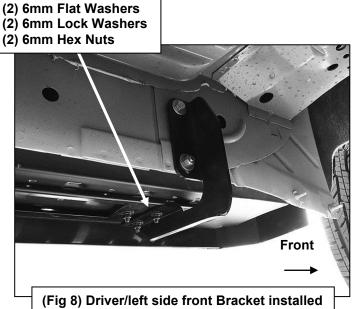
- 7. Attach the Running Board to the Brackets with (6) 6mm Flat Washers, (6) 6mm Lock Washers and (6) 6mm Hex Nuts, (Figures 8 & 9). NOTE: The Running Board is designed to fit close to the vehicle. It may be necessary to loosen the Bracket hardware slightly and tilt the Brackets downward to insert the Running Board between the Brackets and the body.

- (2) 6mm Flat Washers(2) 6mm Lock Washers
- (2) 6mm Hex Nuts
