## Vacuum Brake Booster Plunger Seal Kit

Part# 001 430 0708S

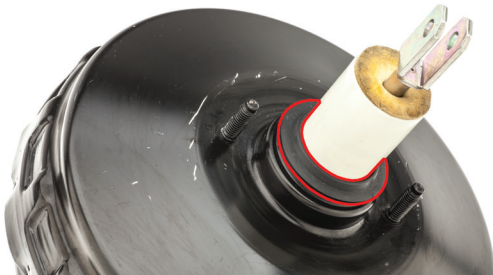
ATE brake boosters found in many Mercedes and Volvo vehicles experience a worn and leaking vacuum plunger seal 03.7718-5028.1, which is characterized by a loud hissing noise and loss of braking power assist. The only option from the dealer is to purchase a complete brake booster assembly, which is exorbitantly expensive.

- Reduced power brake assistance can increase stopping distance
- Brake booster seal leakage can affect fuel injection system and other components that rely on specific vacuum levels

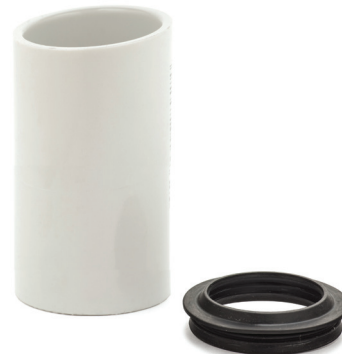
ÜRO Parts has developed an exclusive and simple repair solution for this common failure. ÜRO provides a new replacement vacuum booster plunger seal, which fixes this failure much more economically than replacing the complete booster assembly.

- Durable EPDM reproduction of ATE seal 03.7718-5028.1 for maximum longevity
- Brake Booster Plunger Seal Kit includes seal driver tool and silicone grease
- Easy installation (see instructional video)
