## Mini Cooling Fan Resistor Repair Upgrade

Part# 17 11 7 541 092-PRM

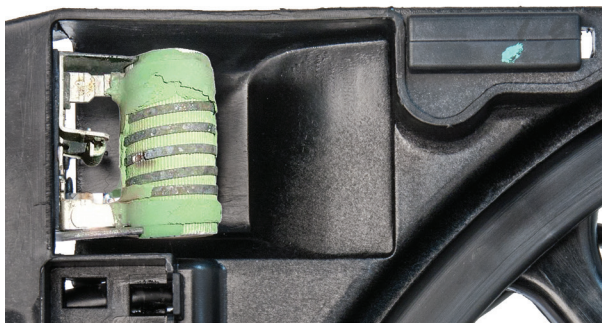
### OEM Design

The Mini Cooper suffers from a common failure of the main cooling fan motor speed resistor, which causes the fan to either stop operating or never shut off. Mounted at the front of the radiator inlet grille, the OE design exposes the resistor to harsh weather elements, promoting corrosion and eventual failure. Mini only offers this resistor as part of the costly complete cooling fan assembly.

- Resistor coil is exposed and unprotected
- Rain, snow, pollutants, blowing sand and flying road debris eventually damage or corrode the resistor winding

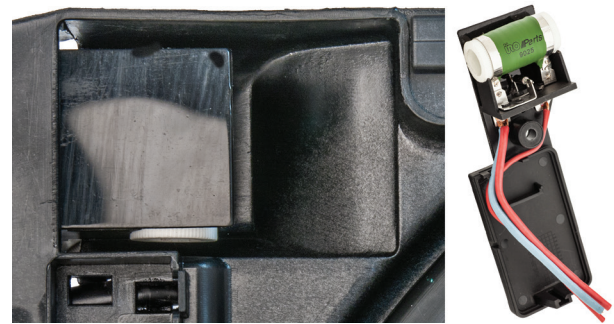
ÜRO Parts developed a repair kit for this cooling fan speed resistor pack that not only saves money by replacing only the failed component, but also provides a more robust repair. The ÜRO Parts Premium Resistor Kit provides a new resistor pack which is similar to the OE design, and adds a durable plastic shield to help protect the resistor coil.

- Protective cover helps shield fragile resistor coil from harsh weather elements, blowing sand, and airborne gravel
- Lifetime warranty
